Powered Vehicle Suspensions

Owner's Manual

GP120

Document #: D9805

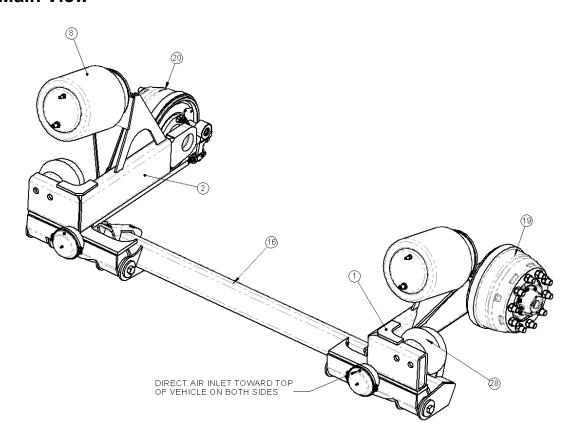
Main View

<u> </u>	ialeriai					
ITEM	QTY	PART #	DESCRIPTION	ITEM	QTY	PART	DESCRIPTION
1	1	7670	AXLE ASY WELDMENT LH	21	2	6967	INNER NUT (IFS)
2	1	7671	AXLE ASY WELDMENT RH	22	2	6968	SPINDLE LOCKWASHER
3	8	8120378	N 1/2-13, GR. 5, ZN	23	2	6969	WASHER, SPINDLE (IFS)
4	16	8120384	SLW 1/2 .523X.873X.135 ZN	24	2	6970	SPINDLE OUTER NUT (IFS)
5	8	8180175	HHB 1/2-13X1.25 GR.5 ZN	25	2	6972	SINGLE ROW TAPER BEARING CONE
6	4	8219758	JN 3/4-16, GR. 5, ZN	26	2	1779	HUB CAP STEMCO #4009
7	2	89415543	FW 1/2 .531X1.25X.100 ZN	27	1	7731	NAMEPLATE - GP120
8	2	7640	AIR SPRING - 1R12	28	2	7639	AIR SPRING - 2B9
9	14	126	HHB 5/8-18 X 2, GR. 8, ZN	29	1	7684	ASY-BRAKE - LH (15 X 4-5 CAM)
10	2	188	POP RIVET	30	2	7977	OIL SEAL ASY - GUARDIAN
11	12	266	HHB 5/16-18 GR5 ZC W/SLW	31	1	7685	ASY-BRAKE - RH (15 X 4-5 CAM)
12	4	3628	HHB 1-14X8.50 GR.8 ZN	32	2	7736	AUTOSLACK-10SP 1.25 CAM GUNITE
13	14	4599	LFN 5/8-18, GR. G, PH	33	2	7737	5/8 COLAR LOCK FOR GUNITE AS

14	4	89422312	LN 1-14 GR C PH	34	1	7735	SHIPPING & ASY-GP120
15	2	103161	N 5/8-18 5 ZN	35	1	D9820	KIT, DRAWING/DOCUMENT GP120
16	1	7682	ASY, AXLE TUBE	35.1	1	D9783	DRAWING, ASSEMBLY GP120
17	2	1784	SINGLE ROW TAPER BEARING	35.2	1	D9805	GP120 OWNER'S MANUAL
18	2	714147-01	HUB CAP GASKET	36	2	7642	TYPE 16 BRAKE CHAMBER
19	1	6766	H&D 10 STUD BS/OB/LH	37	2	7647	OPERATING ROD, BRAKE
20	1	6767	H&D 10 STUD BS/OB/RH	38	2	7646	STUD, SLACK ADJUSTER

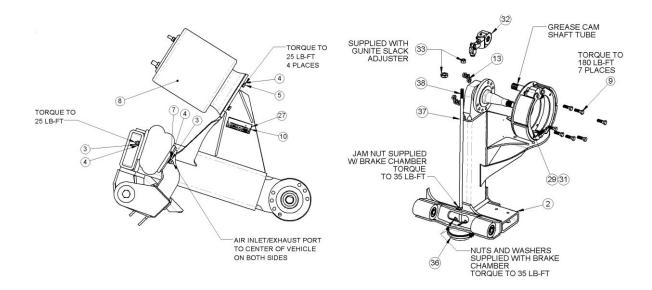
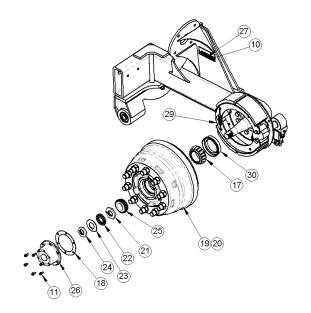
DO NOT APPLY LOCTITE TO END THAT IS TO BE INSTALLED INTO SLACK ADJUSTER

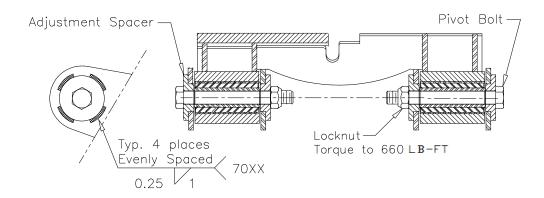
Figure 1: Front Pivot Bolt Inspection

Check front pivot bolts and adjustment spacers for proper installation. The bolts are 1", Grade 8 bolts and the Grade C locknuts are torqued to 660 LB-FT Inspect adjustment spacers for weld. See Figure 1 below.

- 4. If the camber must be adjusted, the inside and outside pivot bushing adjustment spacer welds on the outer pivot bolt must be removed so the adjustment spacers can be adjusted.
- 5. Rotate the trailing arm until a positive castor angle of 1° is achieved and hold in place.
- 6. Tighten the outside pivot bolt to 660 LB-FT
- 7. Remove the indicator and repeat 2 through 4 for the opposite side.
- 8. Tack weld the adjustment spacers in place.
- 9. Reset the angle indicator to zero and check the camber angle on both sides.
- 10. Weld adjustment spacers as described on Sheet 2 of drawing #9783 or Figure 1 on page 10 of this manual.

- 5. Adjust the trailing arm assembly outward from the center until a difference of 7/16 (0.4375) inches is measured from the front of the alignment bar to the rear (Dim. "A" Dim. "B" = 7/16 in.). The linear tolerance band for toe-in adjustment is 0.21 to 0.63 inches. Outward adjustment must be carefully watched so that the overall outside width does not exceed 102 inches.
- 6. Tighten the inside pivot bolt to 660 LB-FT
- 7. Repeat 1 through 4 for the opposite side.
- 8. Tack weld the adjustment spacers in place.
- 9. Verify toe-in setting on both sides.
- 10. Weld adjustment spacers as described on Sheet 2 of drawing #9783 or Figure 1 on page 10 of this manual.

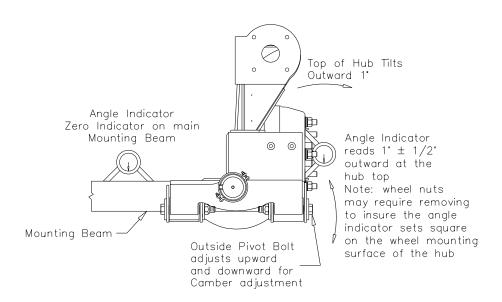
Figure 3: Camber Adjustment

Camber is to be set at $1^{\circ} \pm 1/2^{\circ}$ as illustrated in Figure 3 on page 15.

- 1. Place an angle indicator on top or bottom of the main mounting beam and zero the indicator as illustrated in Figure 3 on page 15.
- 2. Remove the indicator from the beam and place on hub face in a vertical position.
- 3. If the camber is within specification, tighten the outside pivot bolt and torque to 660 LB-FT and proceed to step 8; otherwise adjust.

Reinstall the repaired trailing arm using new fasteners. Snug the pivot bolts only. Do not torque until camber and toe-in have been checked and adjusted if required. (Refer to Figure 3 below or page 4 of the Installation drawing number 9783.)

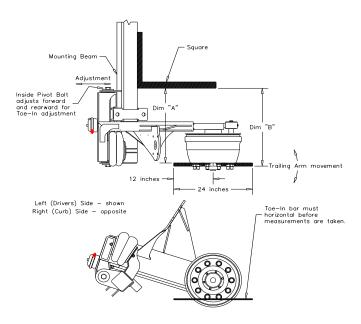
Figure 4: Toe-In Adjustment

Toe-In is to be set at 0.21 to 0.63 inches $(1^{\circ} \pm 1/2^{\circ})$ per side as illustrated in Figure 4 below.

- 1. Locate an alignment bar (or frame square) on the mounting beam, oriented horizontally and held perpendicular to the beam.
- 2. Attach a straight bar of 24 inches in length to the hub face, centered with the spindle and oriented horizontally. Use a level or bubble indicator to verify bar is at a horizontal position.
- 3. Measure toe-in (Dim. "A" Dim. "B"). Measurement must be between 0.21 to 0.63 inches.
- 4. If toe-in is within specification, tighten the inside pivot bolt to 660 LB-FT and proceed to step 8; otherwise adjust.
